殊像寺干预史

History of Interventions

殊像寺干预表 (自1774年至今)
Table of Interventions (1774 to the present)

殊像寺干预表（自1774年至2004年）

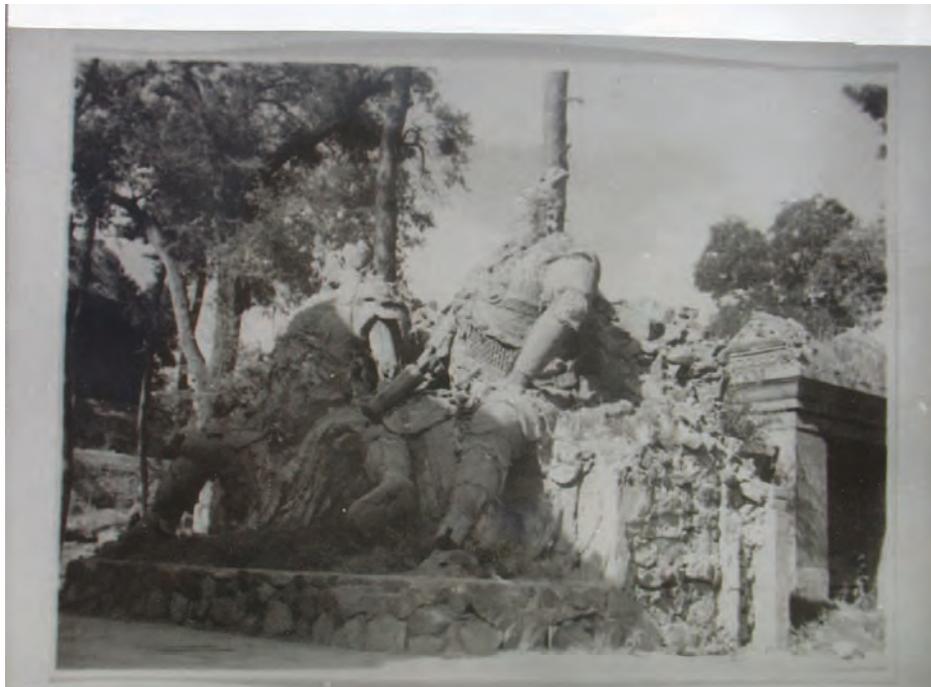
天王殿东侧尚存塑像，1934年。建筑物不复存在，塑像部分存在。
Extant statuary on east side of Tianwang Hall, 1934. Note the building no longer exists and the statues are only partially extant.

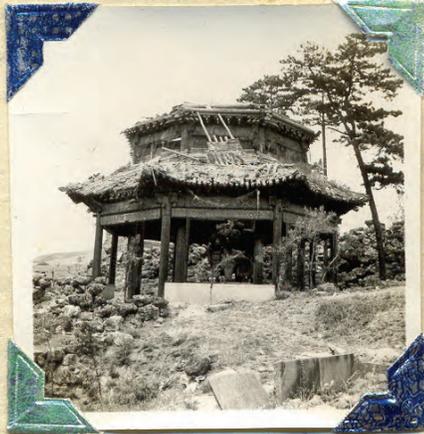
内容 全景 (破损情况)
部位 正前面
底版号 版号 1
时间 1959年
来源 古建队

1. Front view, state of deterioration of Baoxiang Pavilion, 1959

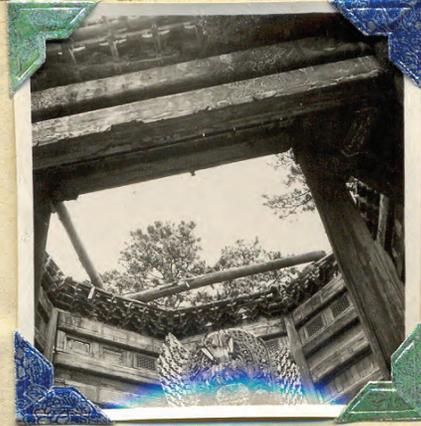
内容 坍塌情况
部位 顶部
底版号 版号 2
时间 1959年
来源 古建队

2. State of collapse of roof of Baoxiang, 1959

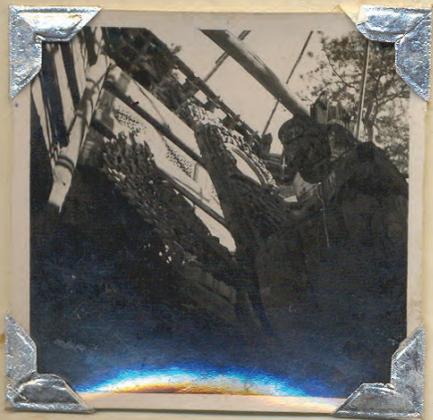
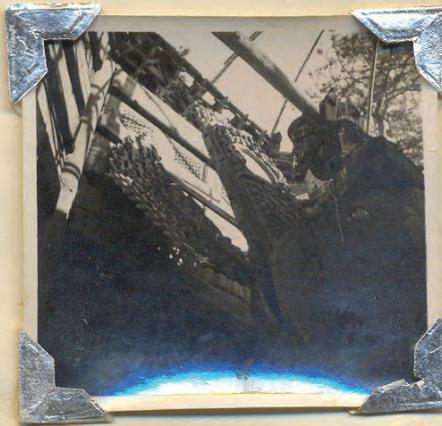
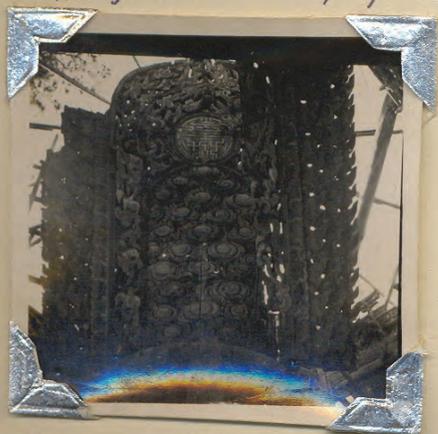
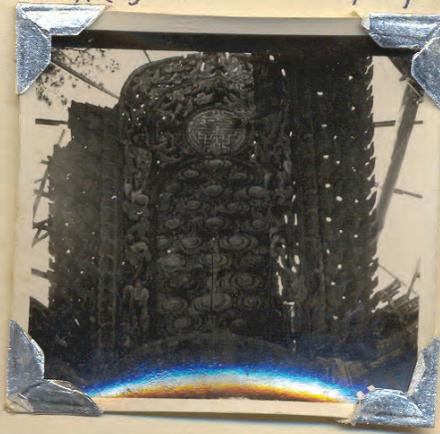
"靠背"残破情况 西侧面
版号 5. 1959.7.

像"靠背"残破情况 西侧面
版号 5. 1959.7.

"靠背"全景 正面上部
版号 6. 1959.7.

3-6. Deterioration of back screen of statues, west side and front, July 1959

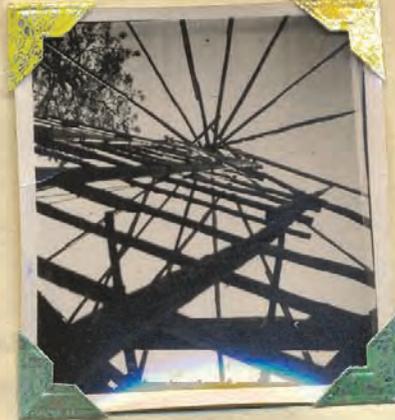
内容 维护情况
部位 内下梯木枋支架情况
底版号 版号 8
时间 1959年
来源 古建队

4. Looking up at fir wood supports inside Baoxiang showing restoration methodology, 1959

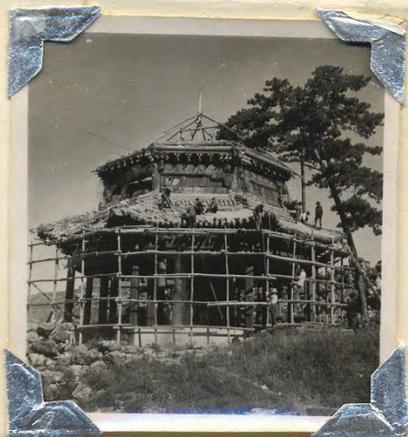
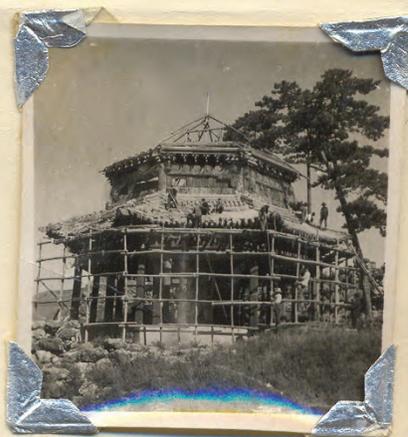
1. 维修情况 前正面
版号 7. 1959. 7.

2. 维修情况 前正面
版号 7. 1959. 7.

1-2. Restoration of Baoxiang, viewed from front, July 1959

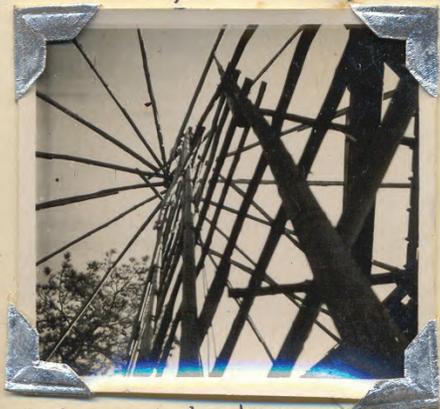
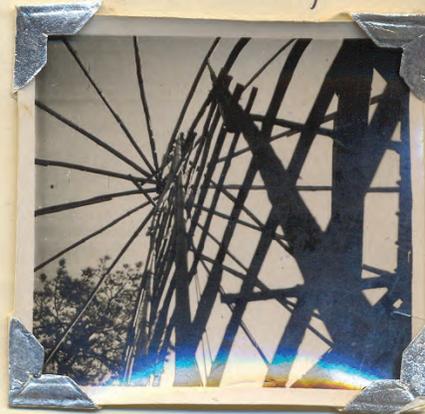
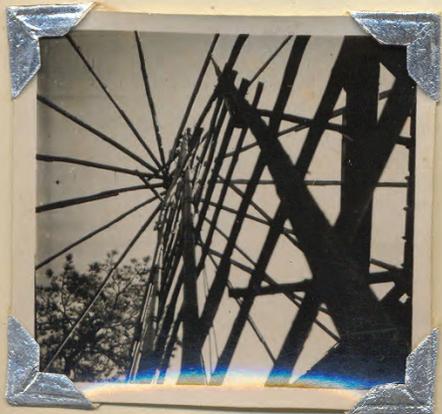
3. 内部用杉木帮友的架木 仰视
版号 8. 1959.

4. 内部用杉木帮友的架木 仰视
版号 8. 仰视 1959年

5. 内部用杉木帮友的架木
版号 8. 仰视 1959年

3-5. Internal view looking up at the dry fir wood frame of Baoxiang, 1959

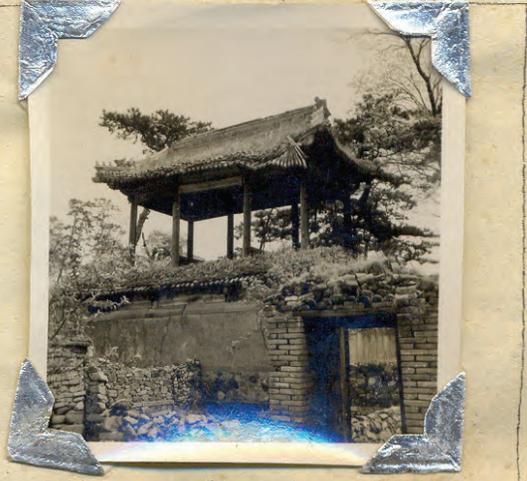
内容 全景背残破状况
部位 背面侧面
底版号 版号 2
时间 1959年
来源 古建筑队

2. State of deterioration of Drum Tower, from the back, 1959

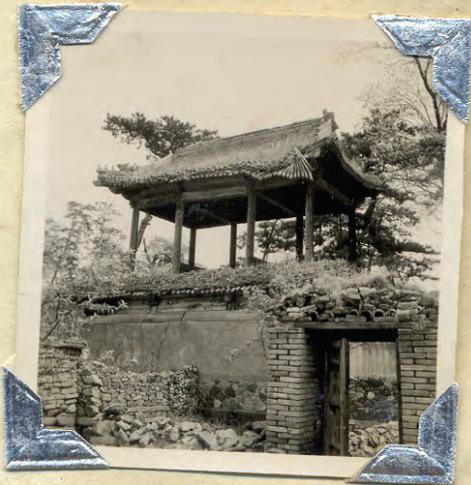
内容 背残破状况
部位 背面侧面
底版号 版号 2
时间 1959年7月
来源 古建筑队

3. State of deterioration of Drum Tower, from the back, 1959

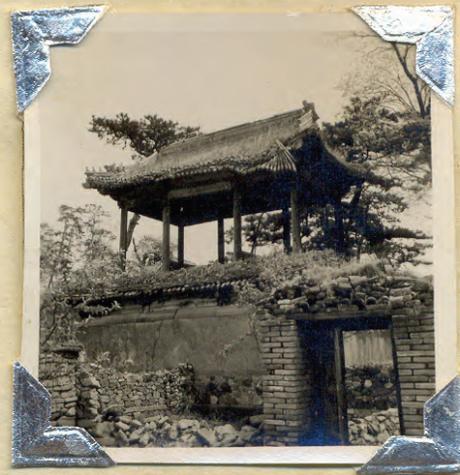
内容 背残破状况
部位 背面侧面
底版号 版号 2
时间 1959. 7月
来源 古建筑队

4. State of deterioration of Drum Tower, from the back, 1959

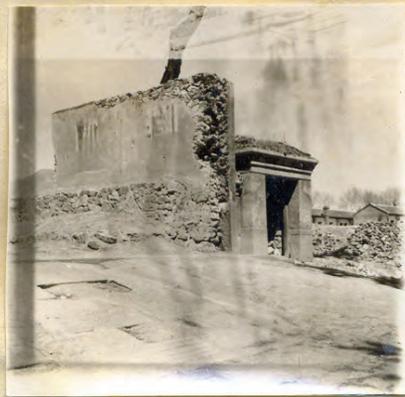
天王殿残破状况

3. State of deterioration of Tianwang Hall

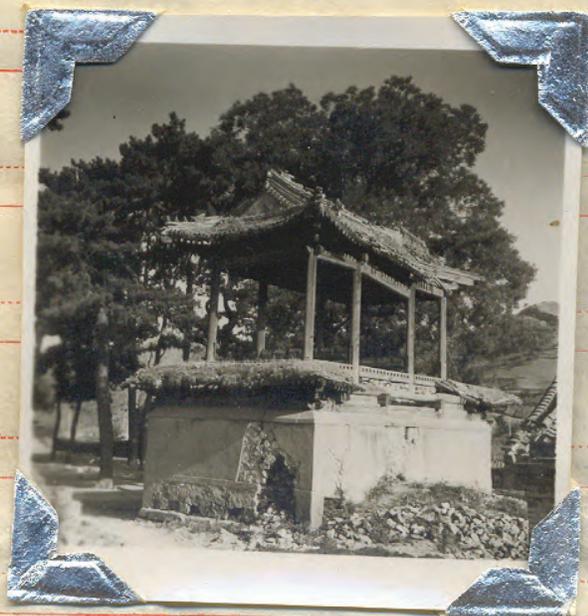
‘鼓楼’北后侧面

看残破情况

1. North side of Drum Tower; state of deterioration

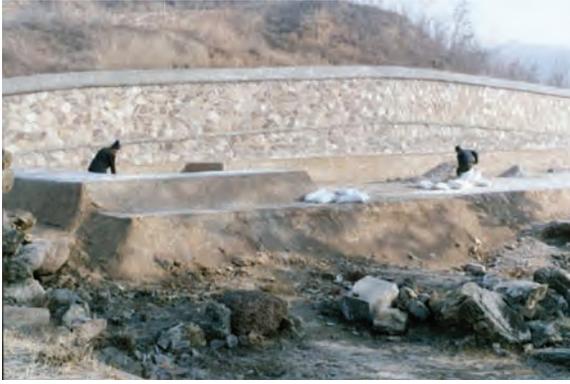
1. 清凉楼，基址回填中
Qingliang Building, reburial in progress

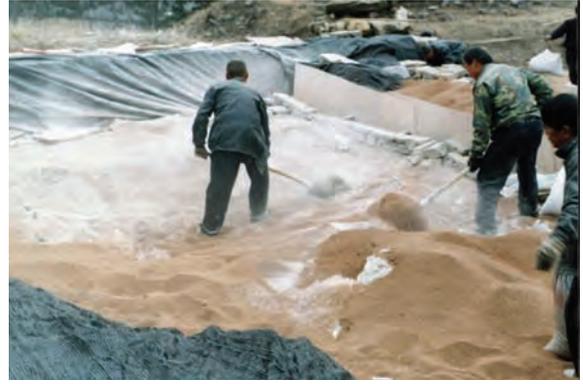
2. 清凉楼，混合回填用的黄土与石灰
Qingliang Building, reburial, mixing soil with lime

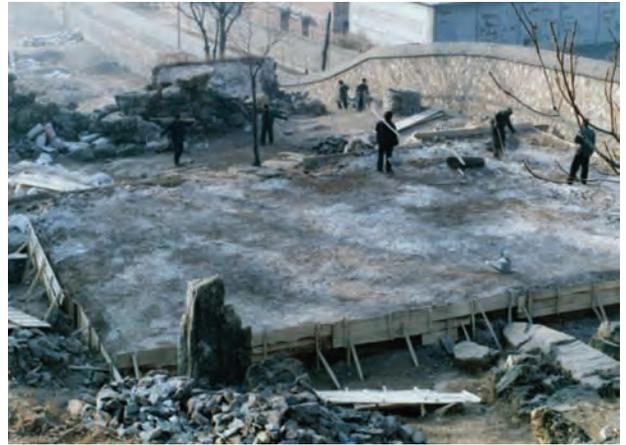
4. 香林室区域，基址回填中
Xianglin Complex, reburial

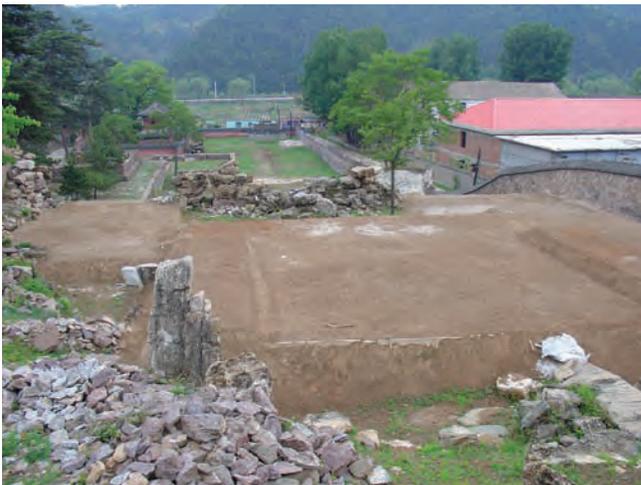
5. 香林室区域，已回填的区域
Xianglin Complex, reburied

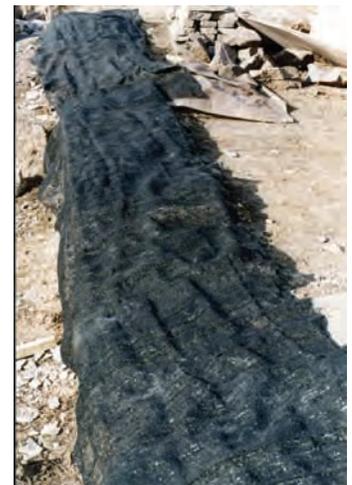
6. 清凉楼，用于回填的分隔层
Qingliang Building, detail of marker layer used in reburial

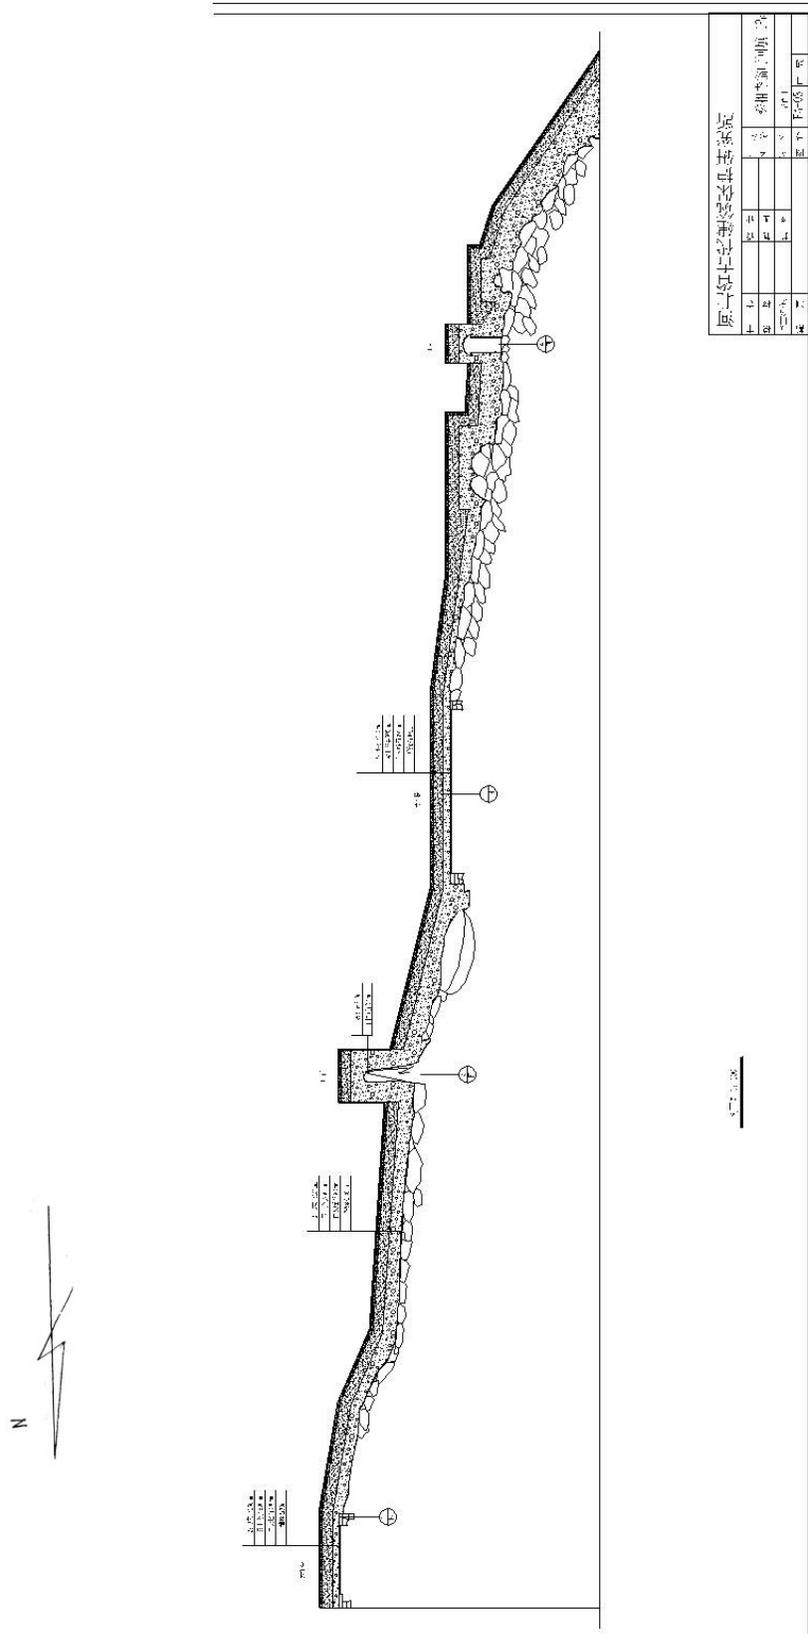
香林室及其附属建筑，基址回填剖面图
Xianglin Complex, site section with specifications for reburial (as designed)

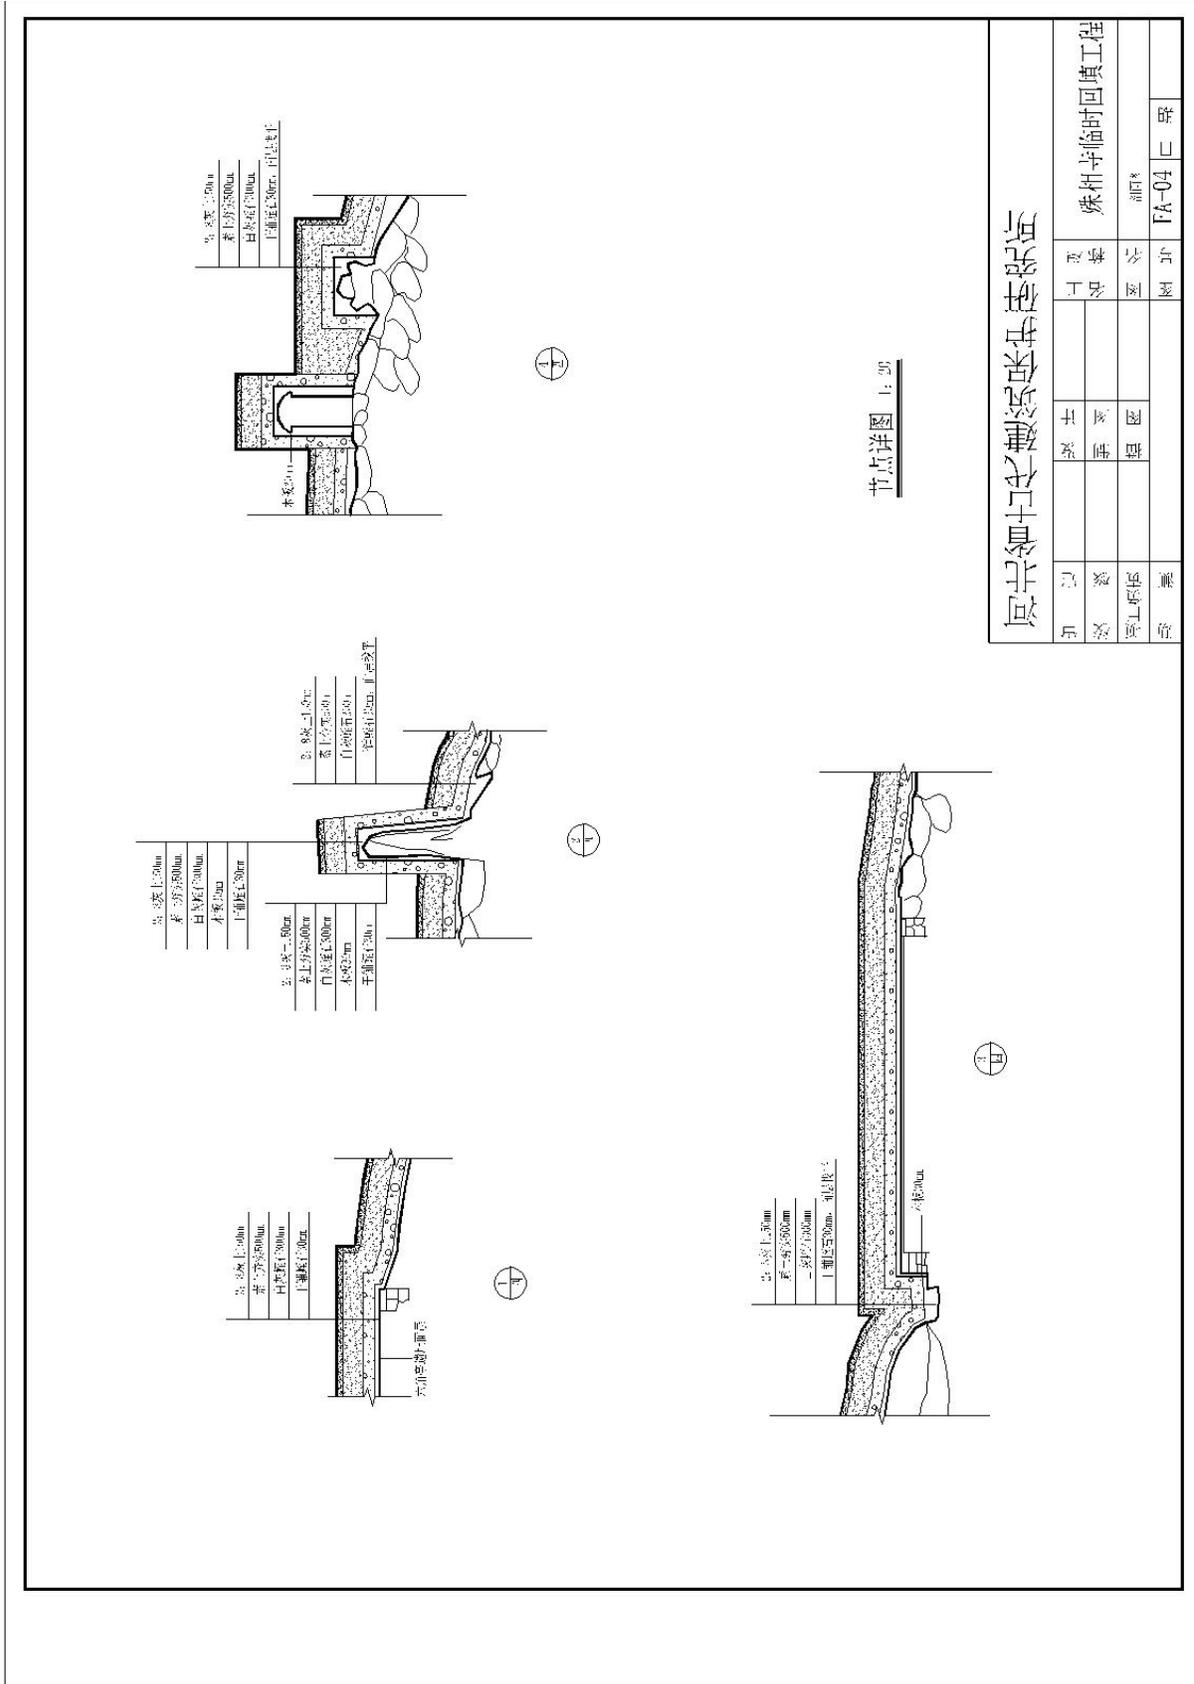
香林室及其附属建筑，基址回填剖面详图
Xianlin Complex, specifications for reburial (as designed)
