殊像寺干预史

History of Interventions

殊像寺干预表 (自1774年至今)
Table of Interventions (1774 to the present)

殊像寺干预表（自1774年至2004年）

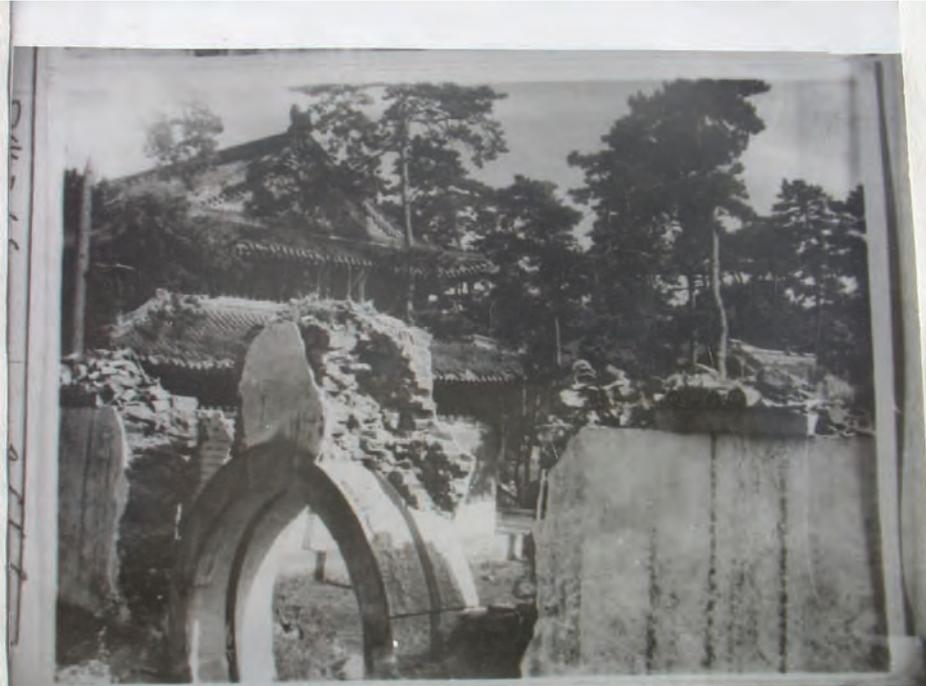
香林室园林景观，圆形月洞门状况良好，背景是会乘殿，1934年。
Xianglin Room Complex Garden view, with round moon gate intact, 1934. Huicheng Hall is in the background.

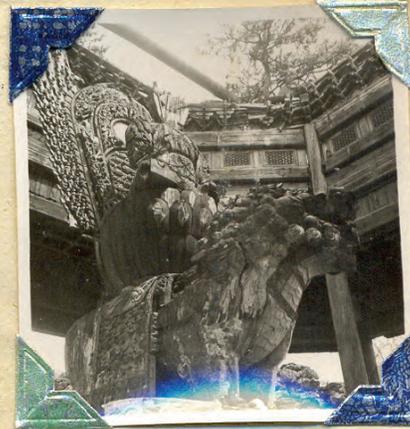
内容 像
部位 西侧正面
底版号 版号 4
时间 1959年
来源 古建队

4. Statue in Baoxiang from the west, 1959

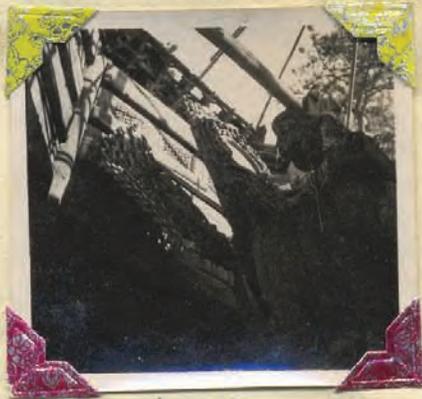
内容 靠背
部位 西侧面
底版号 版号 5
时间 1959年
来源 古建队

1. Back of statue screen, from west side, 1959

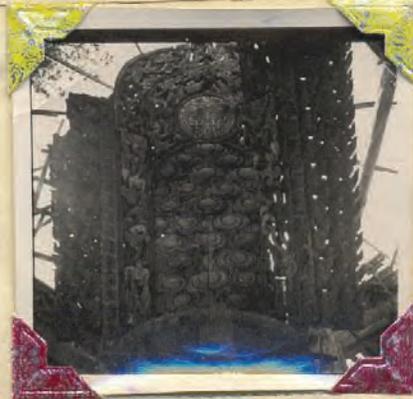
内容 靠背
部位 背面上部全景
底版号 版号 6
时间 1959年
来源 古建队

2. Back of upper section of statues screen, 1959

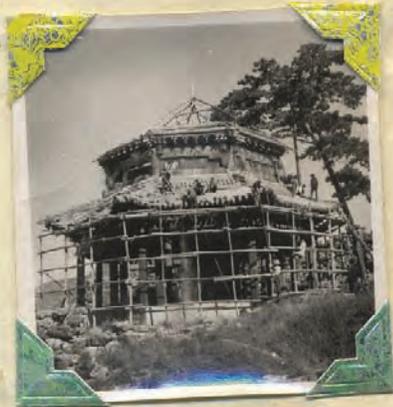
内容 维护情况
部位 前面全景
底版号 版号 7
时间 1959年
来源 古建队

3. View of the restoration of Baoxiang, west side, 1959

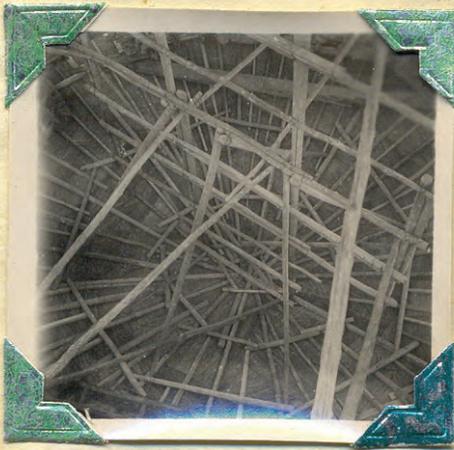
1. 内容 宝相阁的顶内仰视
部位 顶内仰视
底版号 版号 7

1. Baoxiang Pavilion, roof restoration, looking up.
2. Bell Tower, 1959
3. Photo of Manjusri from a private photographer [similar to a Sekino 1933 photo]

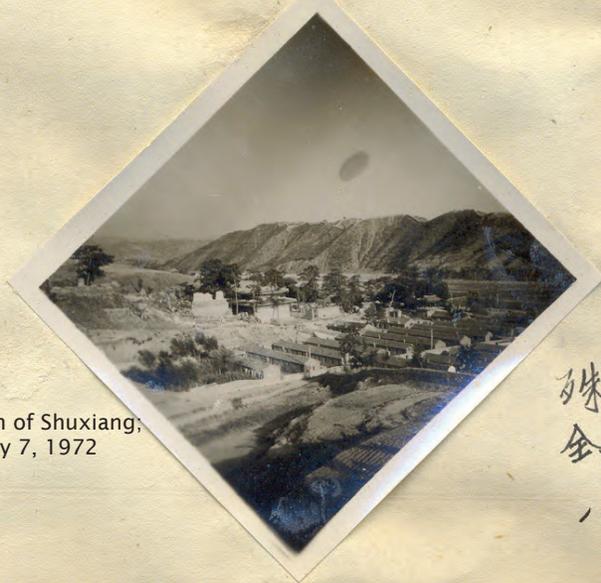
殊像寺现状
全景状况
1972.7.7.

1. Present condition of Shuxiang, panoramic view, July 7, 1972

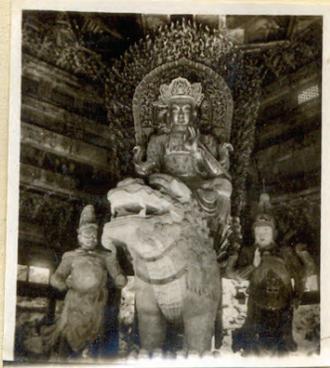
宝相阁文殊菩萨

4. Statue of Manjusri in Baoxiang Pavilion

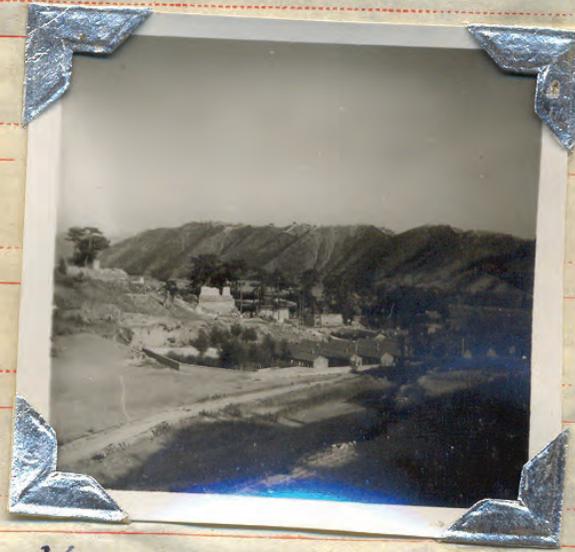
1. Provincial Political
Department approves
use of the temple;
building of a school off
the central axis of the
temple

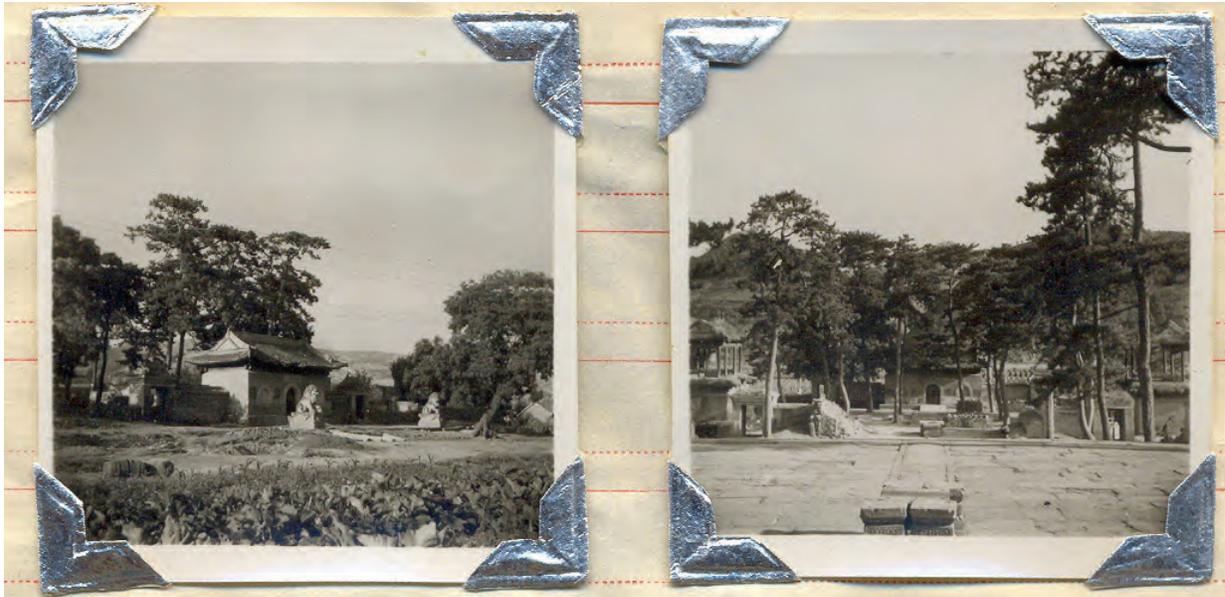
‘山门’前即现状

1. Present condition of Shanmen

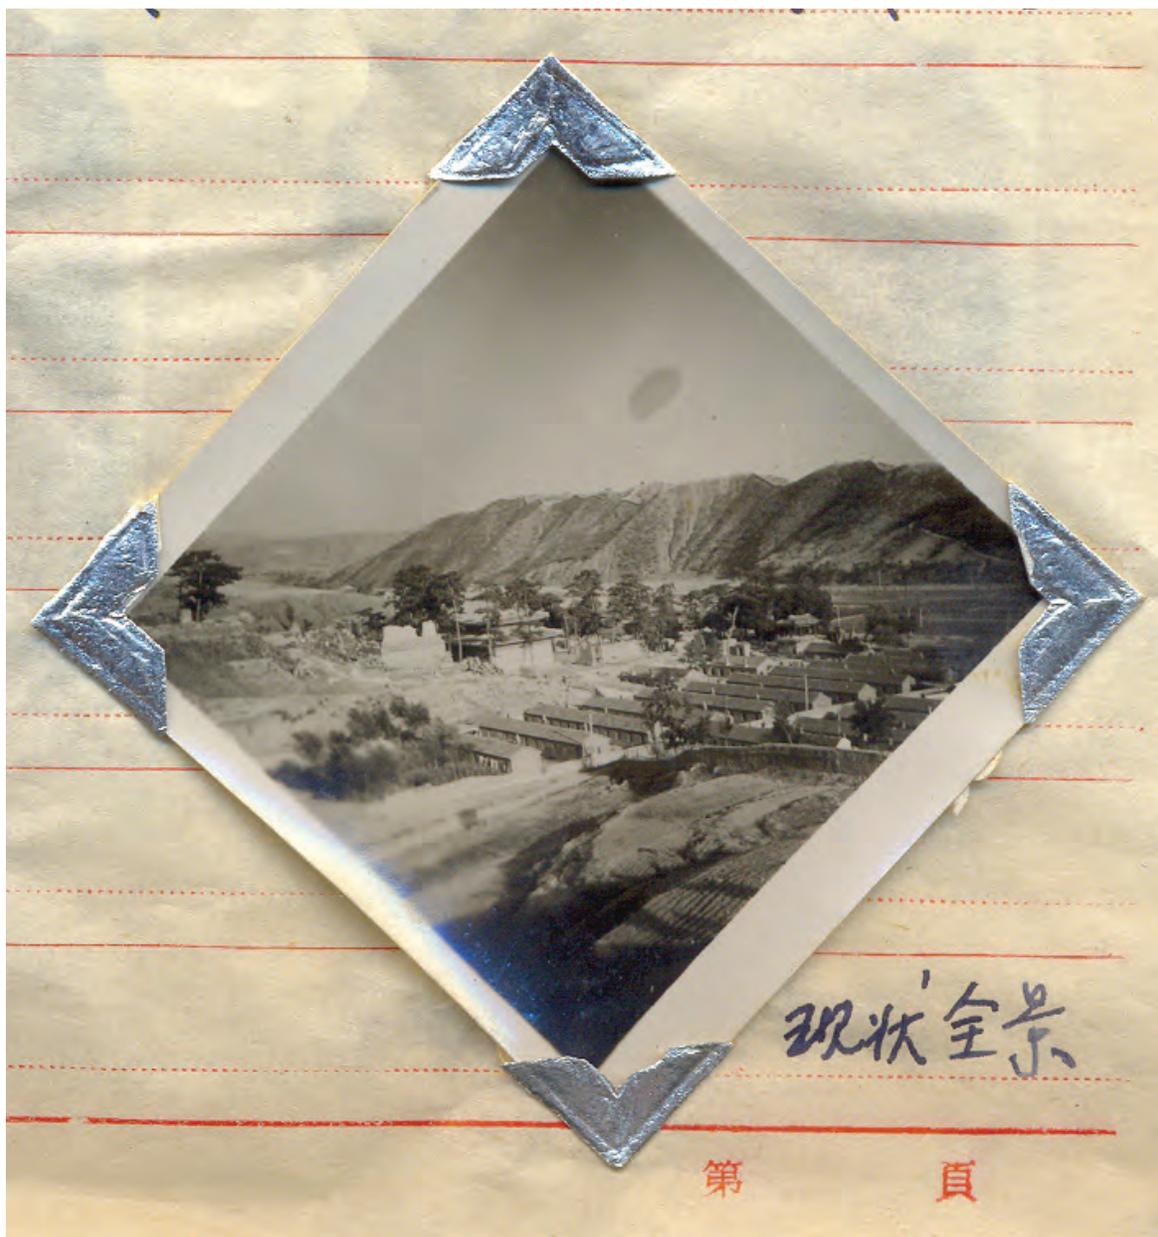
1. General Panoramic view [no date]

[数像寺西面，营区内部；可能是1972年]
[West of Shuxiang Temple, in the military area; may date to 1972]

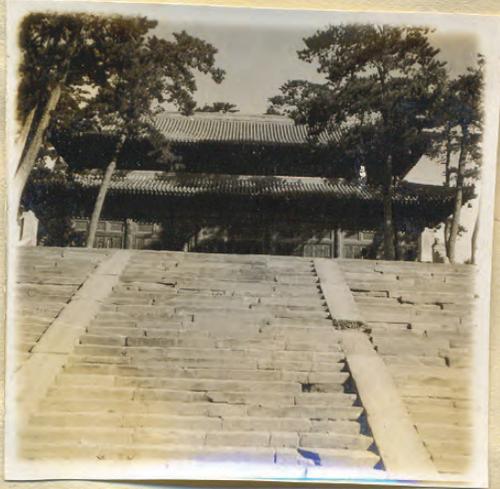
殊像寺会聚层全景

73. 7.
1. Panoramic view of Huicheng Hall, July 1973

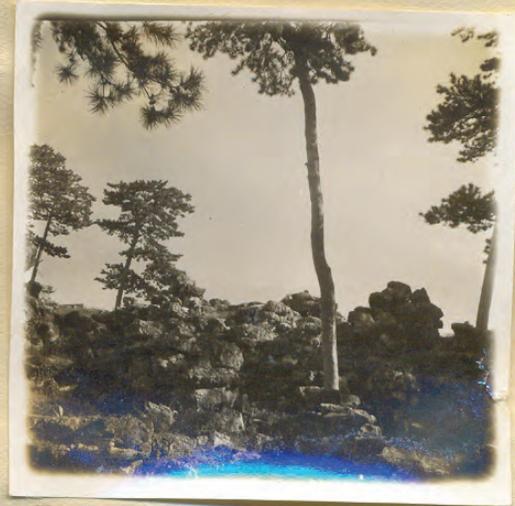
殊像寺假山松树

2. Pine trees in front of rockery, July 1973

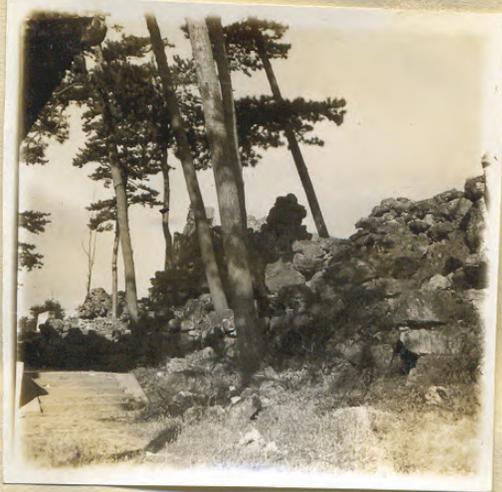
殊像寺假山松树

73. 7.
3. Pine trees in front of rockery, July 1973

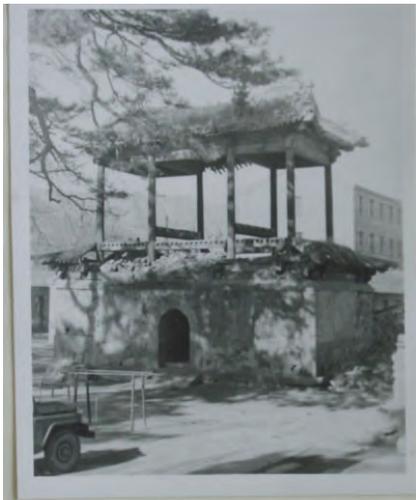
Drum and Bell Towers, April 4, 1981

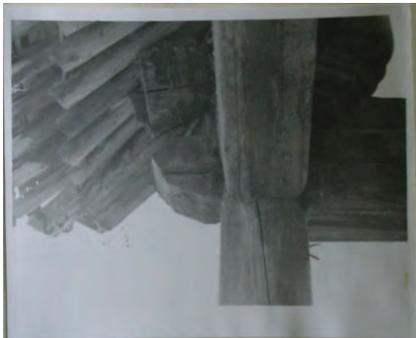
鼓楼上层梁头

Drum Tower, upper eave, April 4, 1981

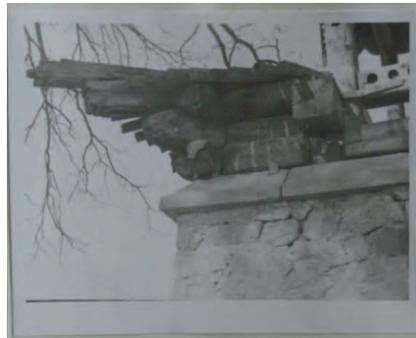
鼓楼下层角梁

Drum Tower, lower eave, corner, April 4, 1981

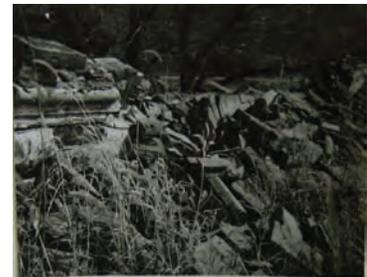
鼓楼上檐正脊

Drum Tower, upper eave, roof ridge, April 4, 1981

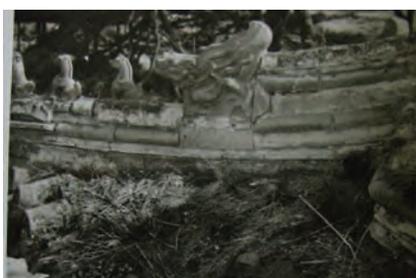
殊像寺 鼓楼上檐正脊北端

Drum Tower, upper eave, north corner ridge, April 4, 1981

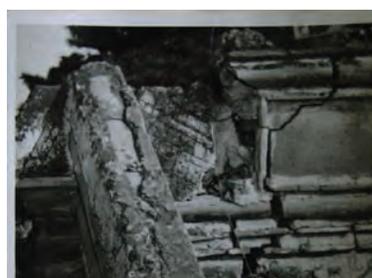
鼓楼上檐正脊北端

Drum Tower, upper eave, north ridge, April 4, 1981

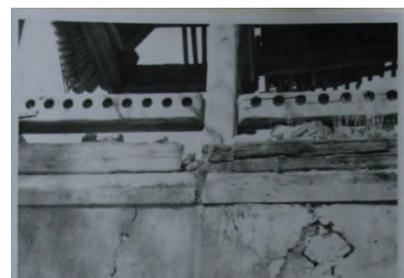
鼓楼承椽枋

Drum Tower, detail, April 4, 1981

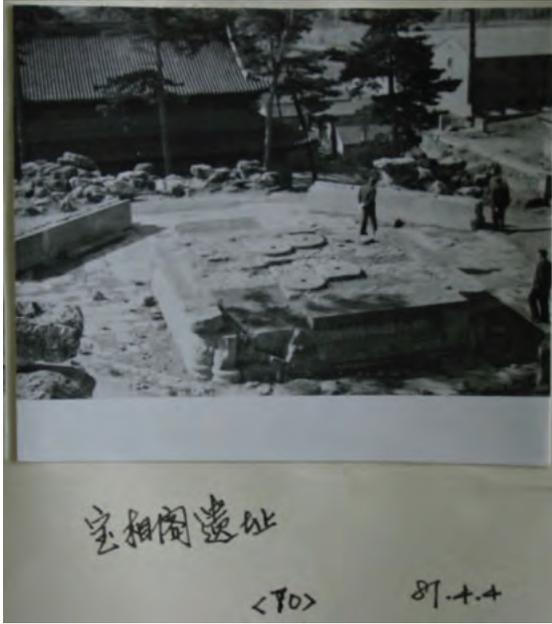
Baoxiang Pavilion, statue base, April 4, 1981

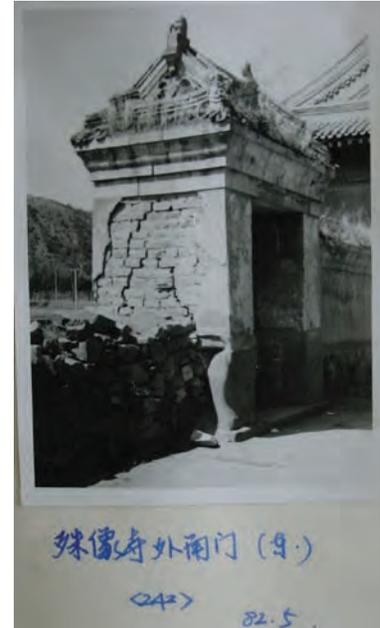
Side gate [east of Shanmen], May, 1982

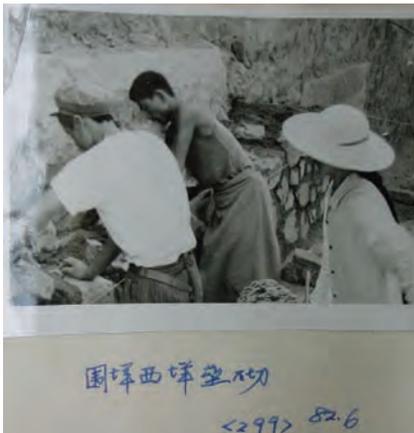
Reconstruction of temple wall, west side, June, 1982

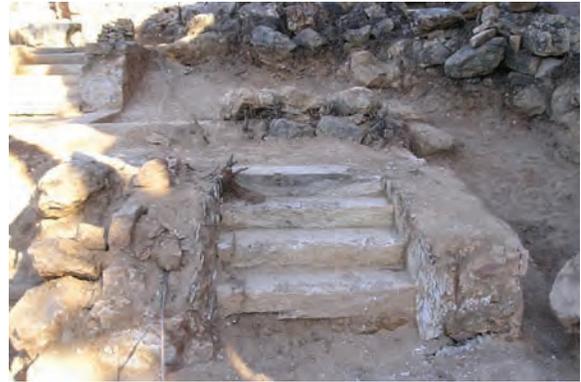
2. 香林室区域，基址发掘出来的鸚鵡岩台阶
Xianglin Complex, excavated tuff stair

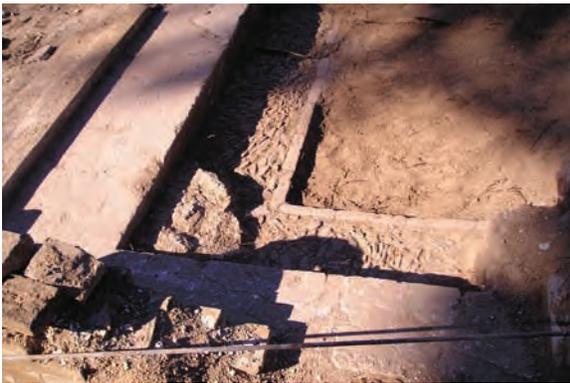
3. 香林室区域，台明石与散水
Xianglin Complex, edge of covered walkway, with drip-line pavement

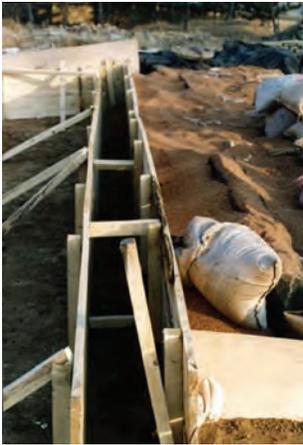
3. 清凉楼，回填用的木结构
Qingliang Building, wooden formwork for reburial
